## Ector Drum, Inc.

### Photo Log

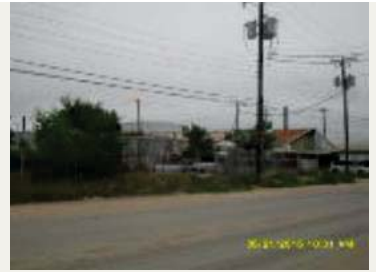
Description: View of site from N. Marco Avenue.

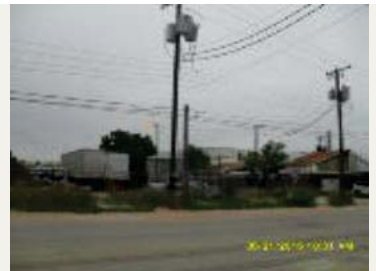
Description: Additional view of site from N. Marco Avenue.

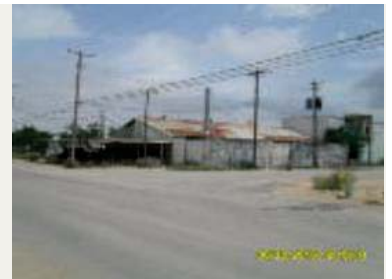
Description: View of site from intersection of N. Marco Avenue and E. Market Street

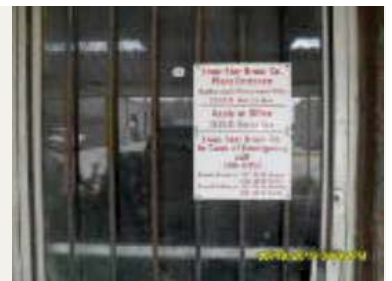
Description: View of sign posted on front door to office building located on N. Marco street.

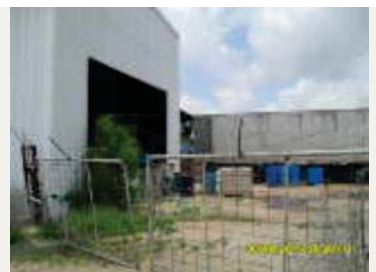
Description: View of gate entrance located on south side of site

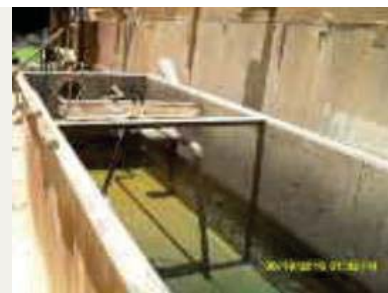
Description: View of trough at Drum Unloading Platform; contains standing liquid

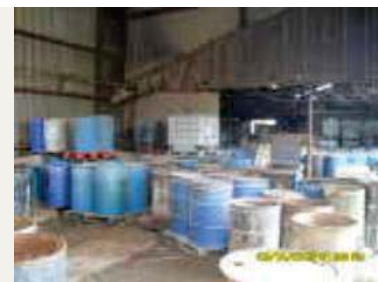
Description: View of drums inside the south building

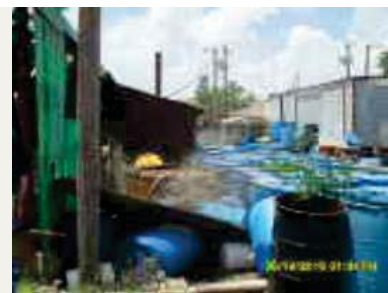
Description: View of drums between south building and secondary containment for Above-ground Storage tanks.

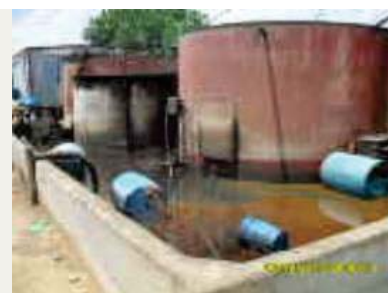
Description: View of three ASTs in secondary containment area,. Notice liquid and drums inside secondary containment

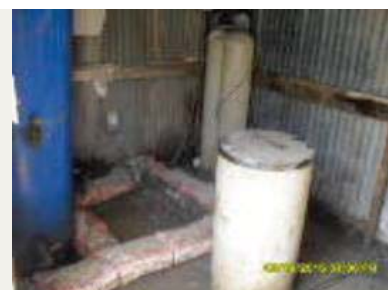
Description: View of well, well tank, and secondary containment surrounding the well inside the well house.

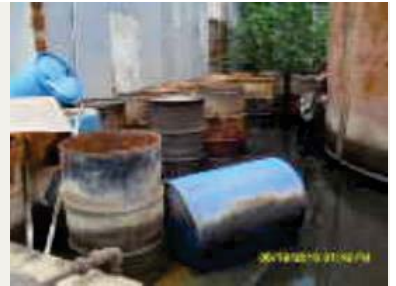
Description: View of drums inside the north section of the AST secondary containment.

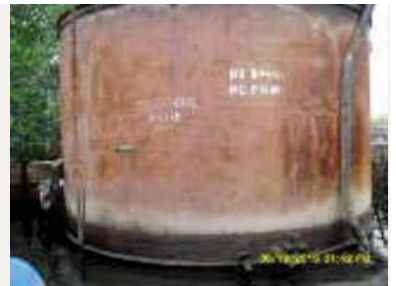
Description: View of AST labeled "Hazardous Waste" inside the AST secondary containment.

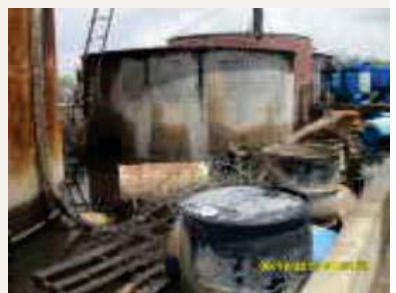
Description: View of ASTs 2 and 3 located in AST secondary containment area. Notice drums and standing liquid inside secondary containment

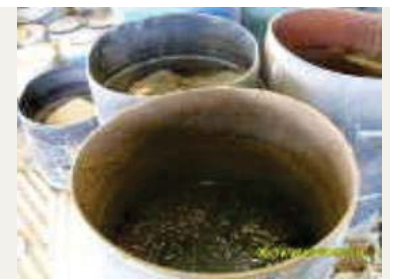
Description: View of material inside drum located in south building.

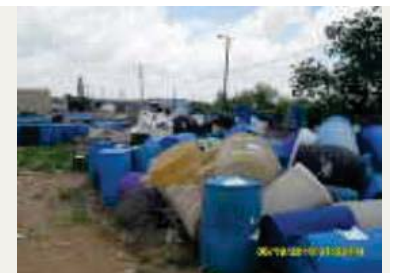
Description: Various containers located on south side of the site.

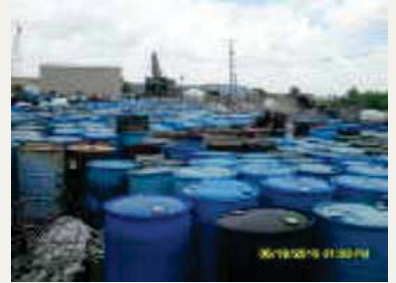
Description: View of drums located in in southeast section of site.

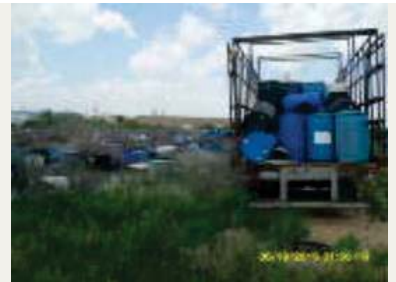
Description: View of drums in east section of site

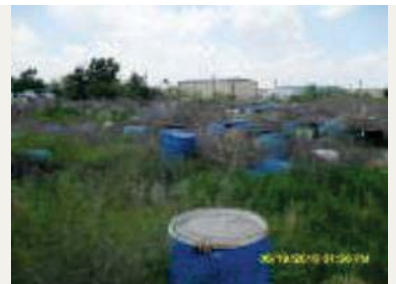
Description: View of drums in central section of site

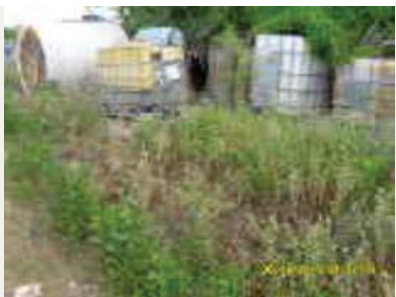
Description: View of 350-gallon tote containers located in southeast section of site

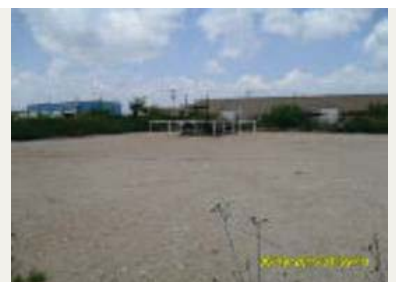
Description: View of oil well located in east section of site

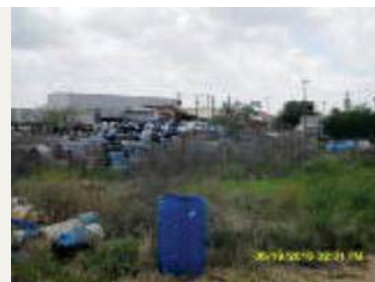
Description: Drums located in center section of site

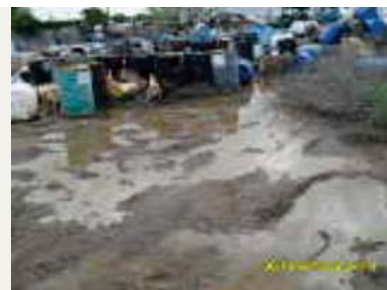
Description: View of drums and tar mats located in center section of site

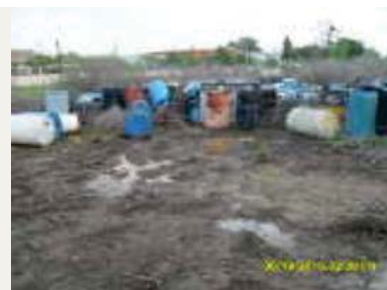
Description: View of sheen on standing liquid in the center section of the site.

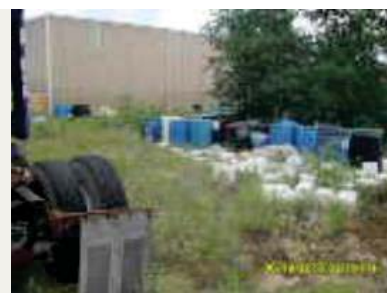
Description: View of additional drums and five gallon plastic containers

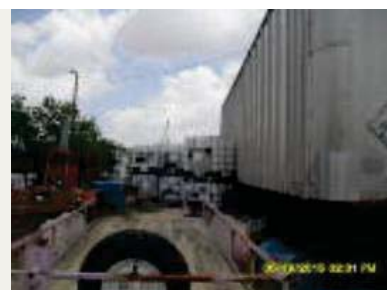
Description: View of stacked 350-gallon totes located in the north section of the site

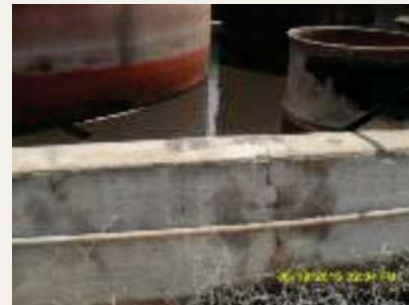
Description: View of cracks in the AST secondary containment system. Notice oily liquid inside secondary containment area

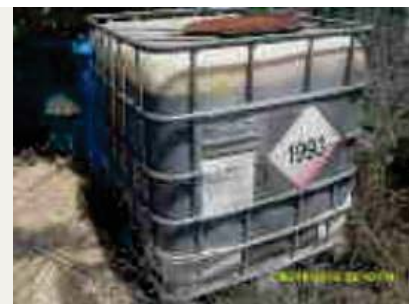
Description: View of 350-gallon tote that is 3/4 full with a liquid material. Located in north section of site.

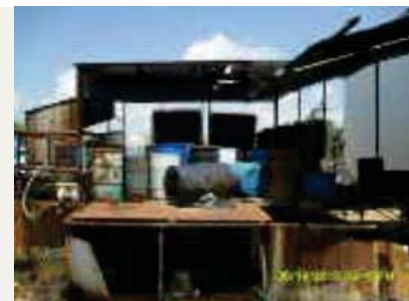
Description: View of Drum Unloading Platform located east of the south building.

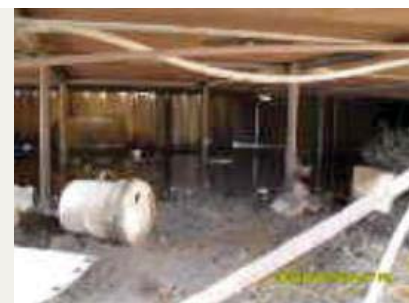
Description: View of standing liquid underneath the Drum Unloading Platform

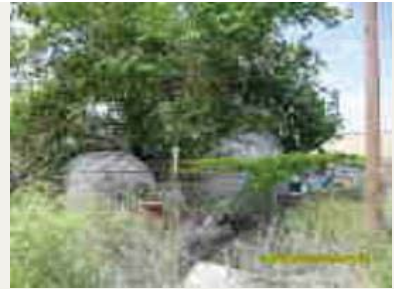
Description: View of two Underground Storage Tanks (USTs) located along the south fence line.

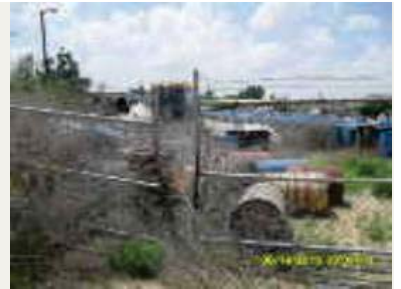
Description: View of gate entrance located in southeast section of site. Opening in gate will allow access to site.

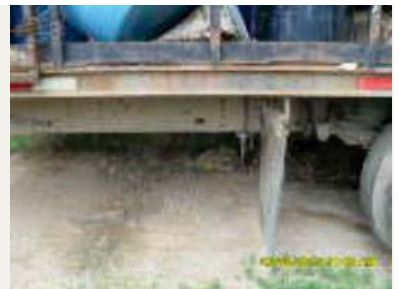
Description: View of dead coyote located in the southeast section of the site.

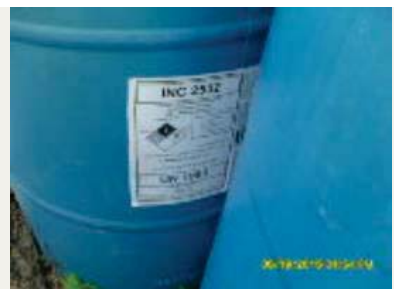
Description: 55-gallon poly drum in southeast section of site labeled as Flammable Liquid N.O.S.; UN1993

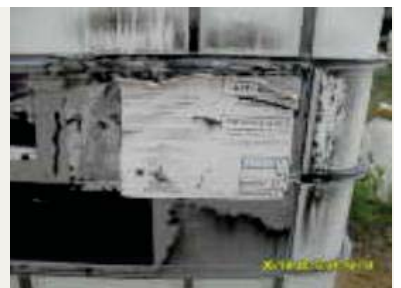
Description: Labeled 350-gallon tote that was located in southeast section of site and sampled/hazcatted.

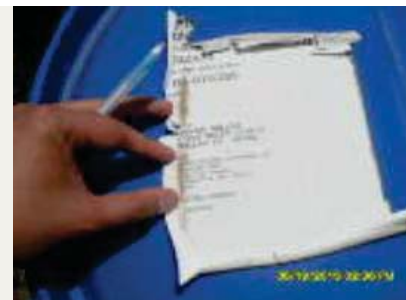
Description: View of label on a 55-gallon poly drum located at the site.

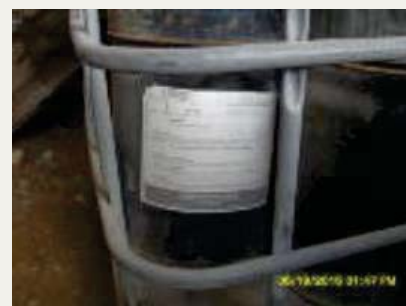
Description: Container inside metal basket located inside south building; labeled as Flammable Liquid, N.O.S., Contains Benzene & Carbon Bisulfide; Endura Products Corp, Midland, TX

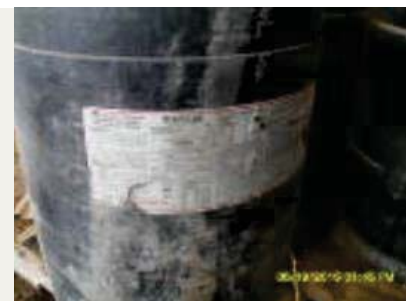
Description: 55-gallon steel drum inside south building labeled as "Dixichlor".

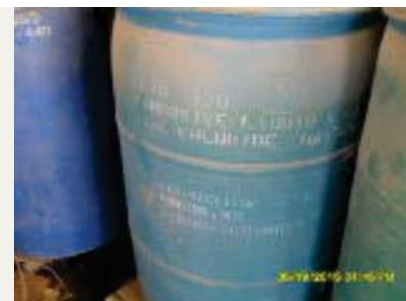
Description: View of 55-gallon poly drum labeled as "Corrosive Liquid N.O.S., Zinc Chloride", Corrosion LTD. Hobbs, NM"

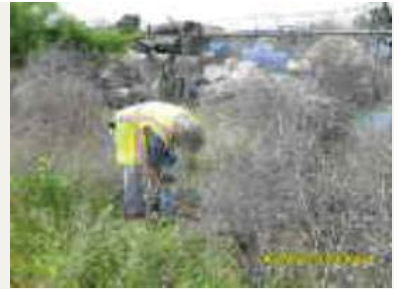
Description: View of soil sampling at station EDS-01, in southeast, offsite drainage pathway.

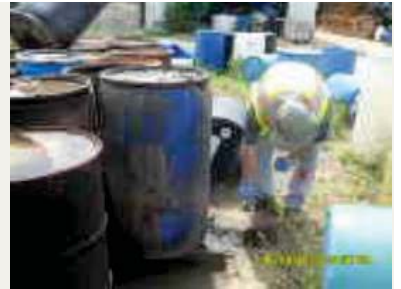
Description: View of sampling station EDS-02 located in the south section of the site, near the gate entrance.

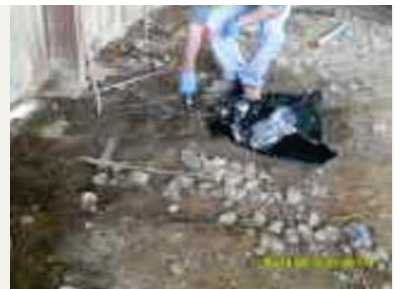
Description: View of soil sampling station EDS-03, located inside the south building, along the south wall

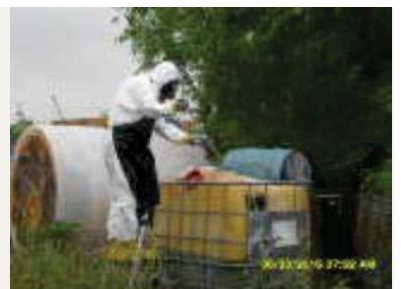
Description: View of sampling/hazcatting a 350-gallon tote located in the southeast section of the site.

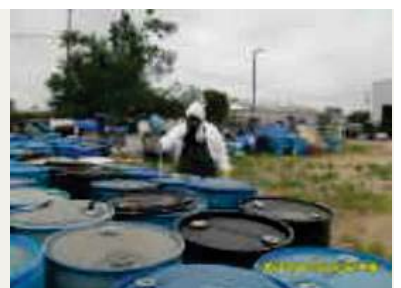
Description: View of sampling/hazcatting a 55-gallon poly drum located in southeast section of site.

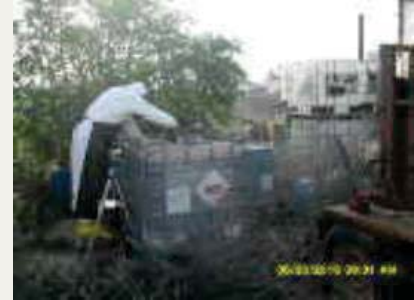
Description: View of sampling/hazcatting a 350-gallon tote located in the north section of the site.

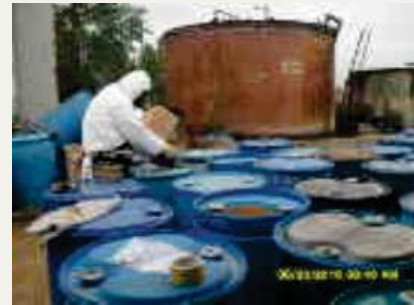
Description: View of sampling/hazcatting a 55-gallon poly drum located between the AST secondary containment area and the south building

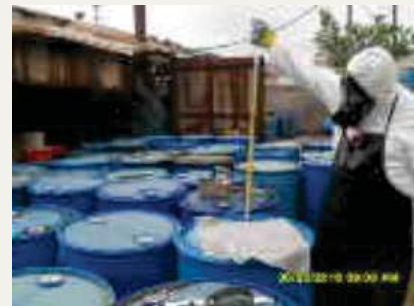
Description: View of sampling/hazcatting a second 55-gallon poly drum in area between south building and AST secondary containment area

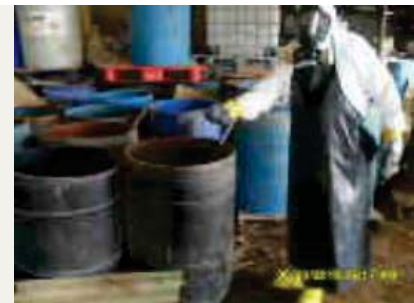
Description: View of sampling/hazcatting at station EDL-10, inside south building

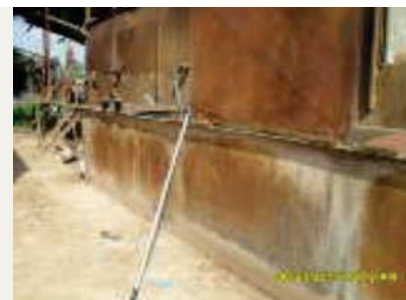
Description: View of sample station EDL-08, the trough associated with the Drum Unloading Platform.

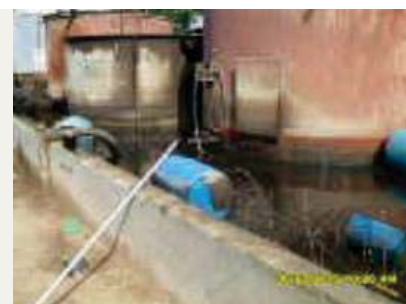
Description: View of sample station EDL-08, the AST secondary containment area.

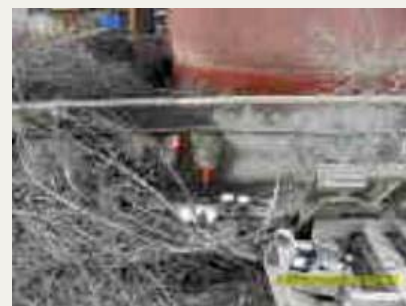
Description: View of soil sample station EDS-04, located on the southeast corner of the AST secondary containment area

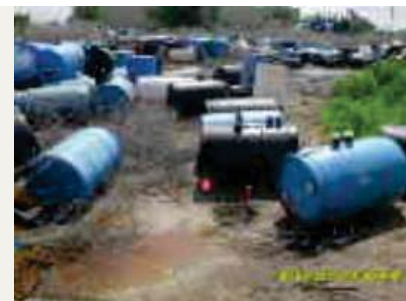
Description: View of soil sample station EDS-05/07, located in the central section of the site.

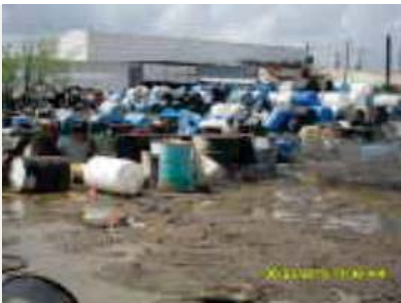
Description: View o soil sampling station EDS-06, located in the central section of the site.
